FINAL REPORT
DEVELOPMENT OF IMPROVED GRAPHITE
FIBER COMPOSITES

14 April 1972 - 11 May 1973

Prepared for: Naval Air Systems Command
Washington, D.C.

Under Contract: N00019-71-C-0166

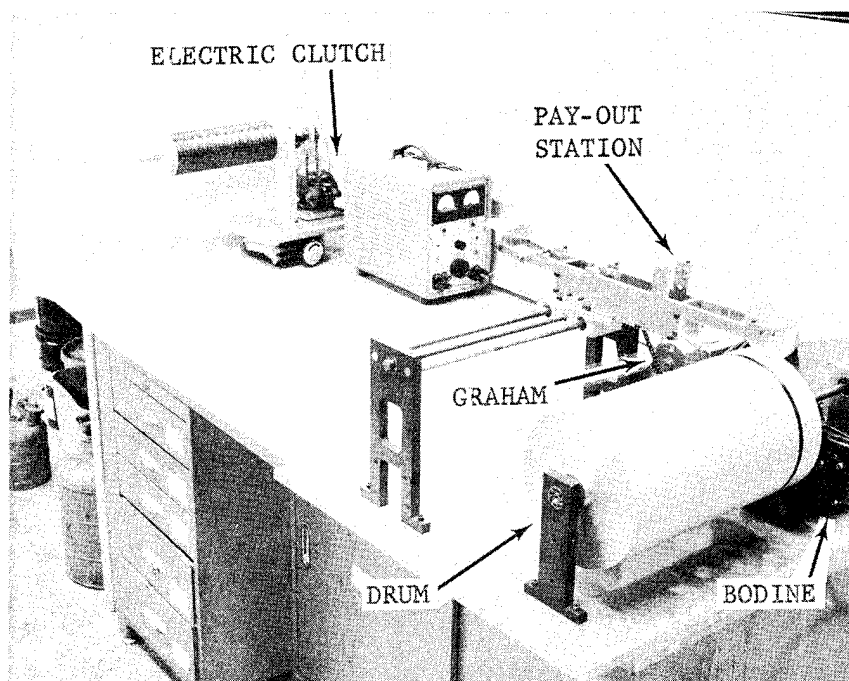
FIGURE 1. EQUIPMENT SET-UP FOR FABRICATION OF TEST PANELS.

The fibers are dry wound over a 0.003-inch thick sheet of Armalon 403F "Teflon" coated glass fabric placed on a drum 25.08 inches in circumference. Fiber tension is controlled as the fiber comes off the spool through the use of a Stearns electric clutch shown in the upper left corner of Figure 1. Drum speed is controlled by utilizing a Bodine dc variable speed drive motor. The Bodine motor also drives a Graham variable speed drive

The third phase supplemental reinforcement interply materials were fabricated into plies separately and B-staged with Narmco 1004 epoxy resin with the exception of boron filament reinforcement material. The boron was purchased as a preimpregnated tape from 3M Company identified as SP-272 Epoxy-Boron filament prepreg. The prepreg properties are described in Appendix A. The prepreg resin used by 3M is a high fracture toughness epoxy resin identified as PR-279. The material as cured results in a per ply thickness of 0.005 inch. All remaining interply materials were prepared by drum winding as illustrated in Figures 1 through 4.

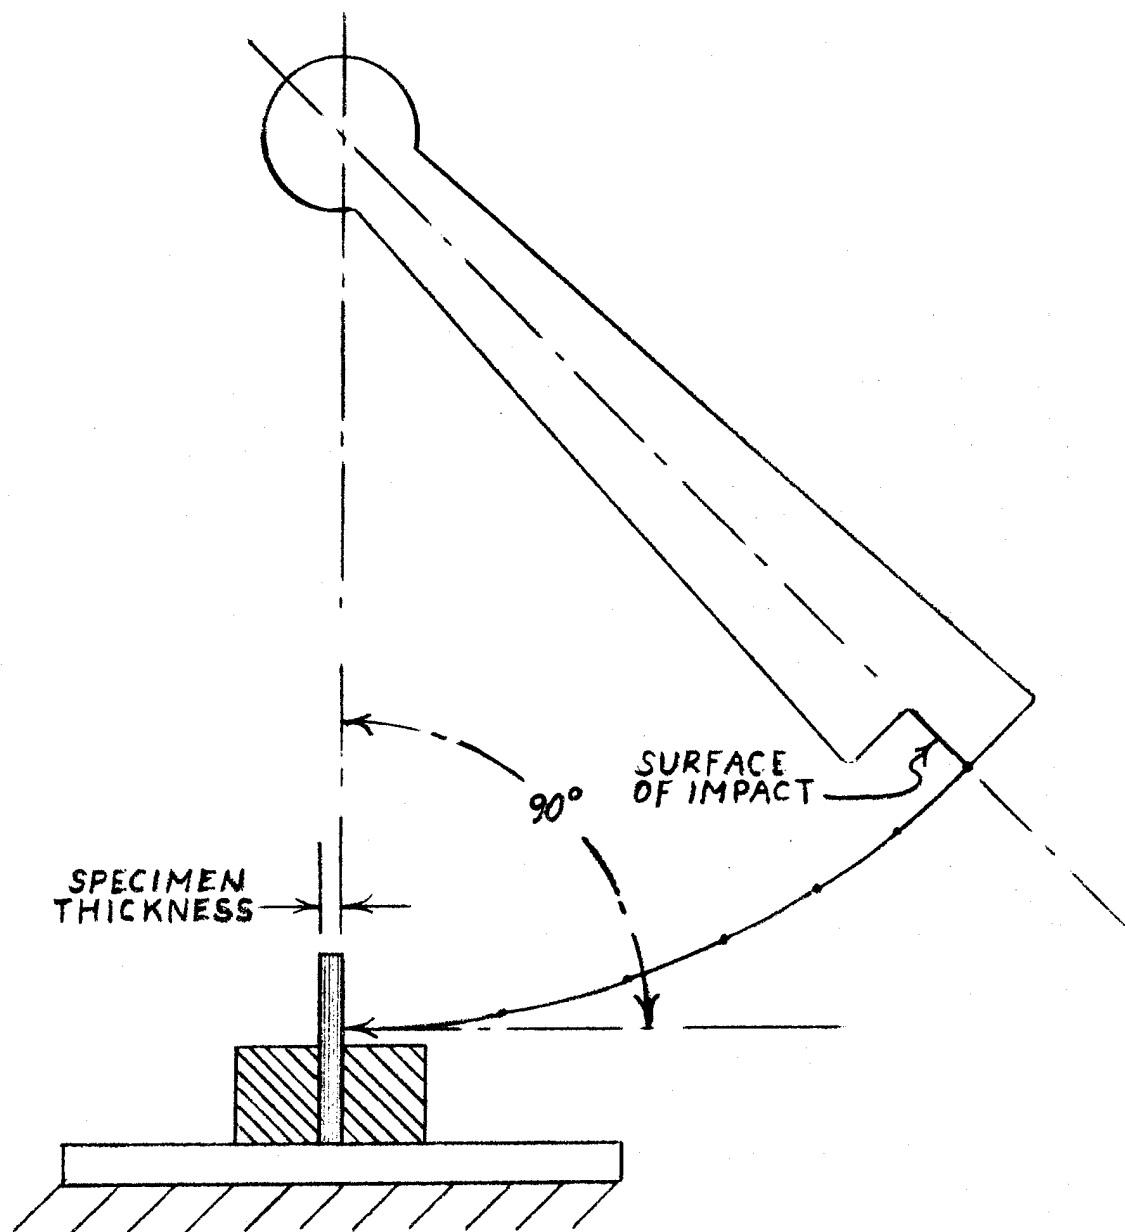
FIGURE 10. IMPACT TEST SETUP

Figure 10. An unnotched specimen configuration 0.5 x 2-1/2 inches was used. The specimen is gripped in vise type grips with 1/2 of its length free. The pendulum type striker head is released and impacts the free end of the specimen. The energy absorbed is recorded in foot-pounds. The results are then normalized per inch of width and thickness so that relative analyses can be made. The specimens can be tested in either longitudinal or transverse impact mode. Both were tested in the flatwise condition.

The impact testing was conducted at Delsen Corporation. An Izod type specimen was utilized and tested per ASTM-D-256, Method A as shown in

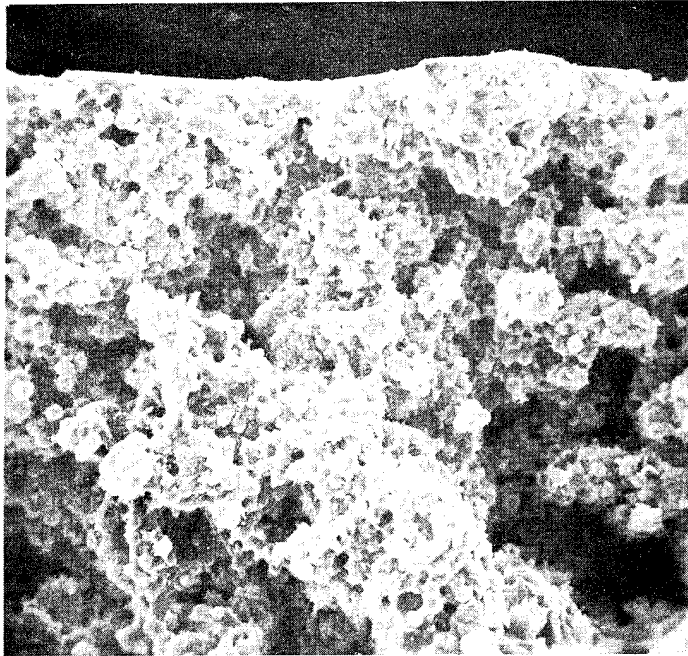
FIGURE 20. 200X SEM - TENSILE SIDE OF IMPACT SURFACE PANEL #1, MODULITE 5206

The particular phenomenon associated to each fiber type was further studied through the use of scanning electron microscopy. Selected longitudinal impact specimens were prepared and the fracture surface studied and photographed. The photographs appear as Figures 20 through 31. Figures 20, 21, and 22 show the fracture surface associated with Modulite 5206, panel No. 1. Little evidence of fiber pullout is evident in Figure 20. The fibers have

undergone tensile failure promoting cleavage of the matrix normal to the fiber axis. This failure sequence is normal for composites with high filament volumes exhibiting high fiber/matrix bonding characteristic of the surface treated graphite fibers. Strain energy released by a broken fiber must be absorbed locally to prevent propagation of an unstable crack. Failed graphite fibers in Figures 21 and 22 show the adherence of resin to fiber and the fluted nature of the fiber surface thus helping to promote the adherence of the matrix.

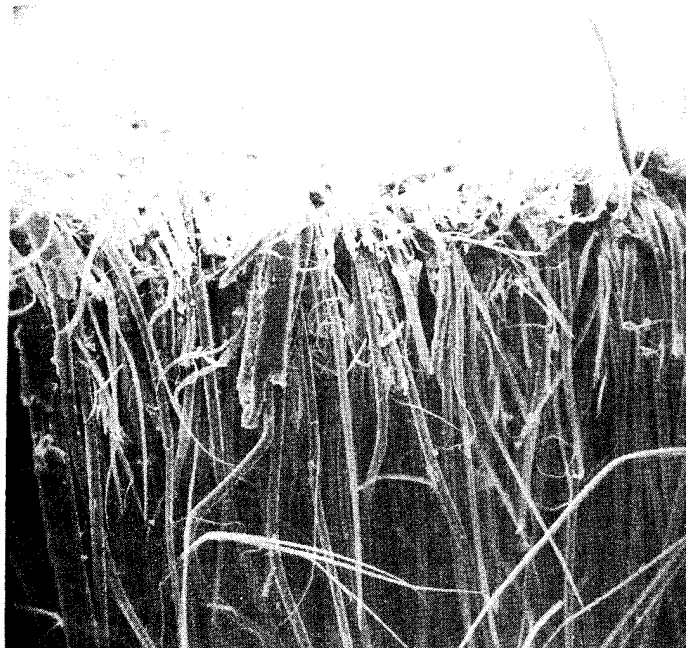
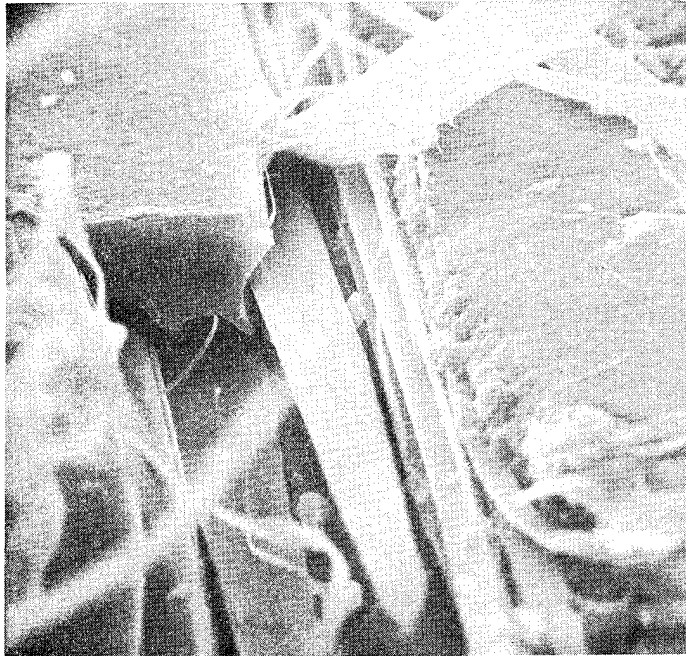
FIGURE 23. 238X SEM - TENSILE SIDE OF IMPACT SURFACE PANEL #2, PRD-49, TYPE III

Figures 23 and 24 depict the impact fracture surface associated with PRD-49 III, panel No. 2. A high degree of fiber debonding and pullout in Figure 23 is present. A close examination of a fractured PRD-49 fiber in Figure 24 shows that the fiber has undergone a complete catastrophic failure over a considerable length of the fiber. In addition to absorbing energy by debonding, the PRD-49 fiber shows an ability to absorb relatively larger amounts of energy during fracture because of the very nature of its type of failure. The smooth appearance of the impression left by the PRD-49 fiber in the matrix at the left edge of the fractured fiber should be noted. Figure 31 also shows the smooth surface associated with a PRD-49 fiber. This smoothness of the PRD-49 fiber surface prevents the high degree of mechanical interlocking of fiber to matrix and subsequently is a cause for the reduced transverse tensile and interlaminar shear strengths (the other principal cause being a relatively lower degree of chemical bonding).

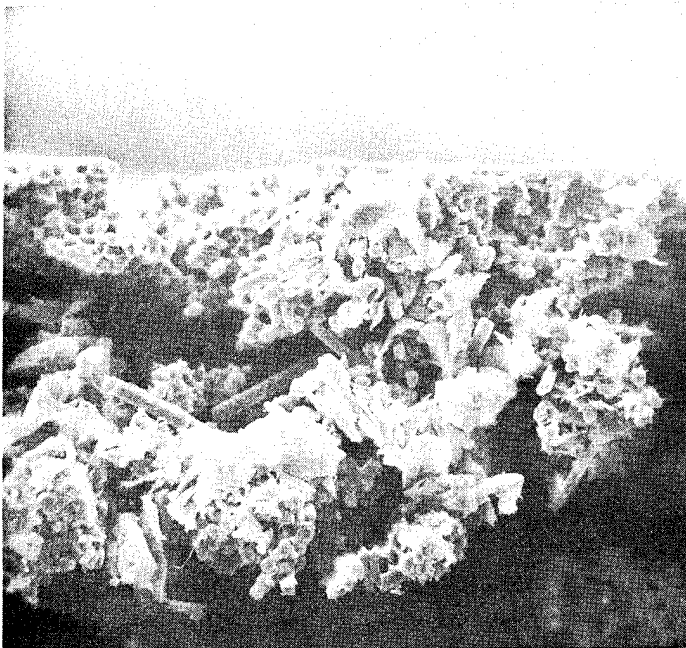
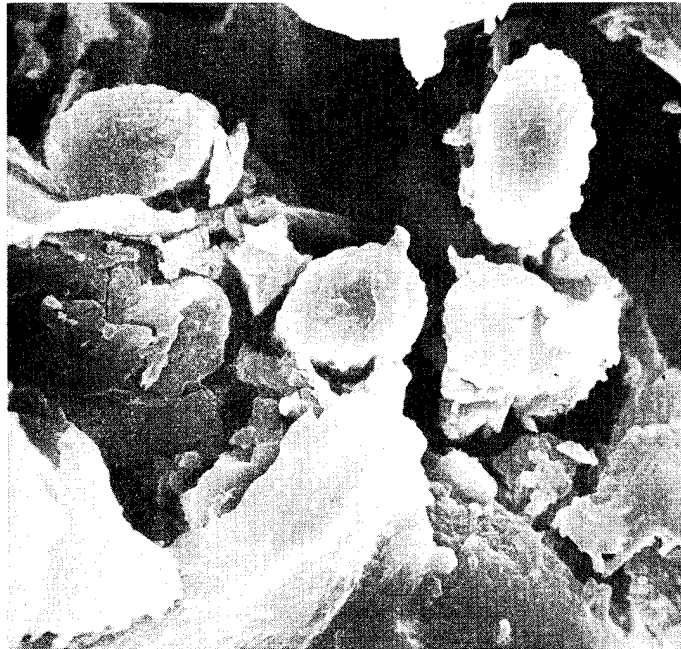
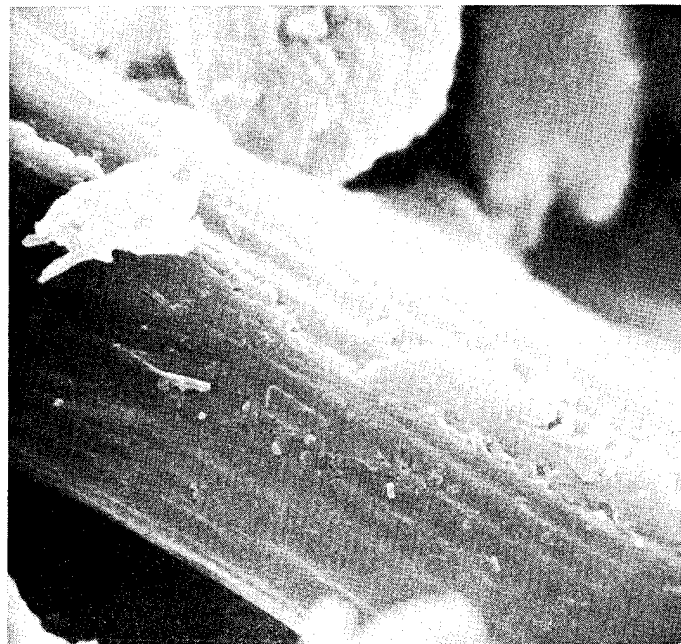
FIGURE 25. 238X SEM - TENSILE SIDE OF IMPACT SURFACE PANEL #3, THORNEL 400

Figures 25, 26, and 27 show the impact fracture surface associated with Thornel 400, panel No. 3. Some fiber debonding and pullout is evident although the specimens still underwent a cleavage-type fracture. The higher initial strain energy capability of the fiber relative to the Modmor II filament is believed to be the reason why the impact resistance of the Thornel 400 is higher than the Modulite 5206 panel. A fluted surface is also associated with the Thornel 400 fiber, shown in Figures 26 and 27, thus resulting in relatively higher interlaminar shear strengths. The impact fracture surface of the boron epoxy, panel No. 4, is shown in Figures 28 and 29. Its surface exhibits a very brittle, cleavage mode of failure. High interlaminar shear strengths indicate good chemical bonding of fiber to matrix as shown in Figure 29.

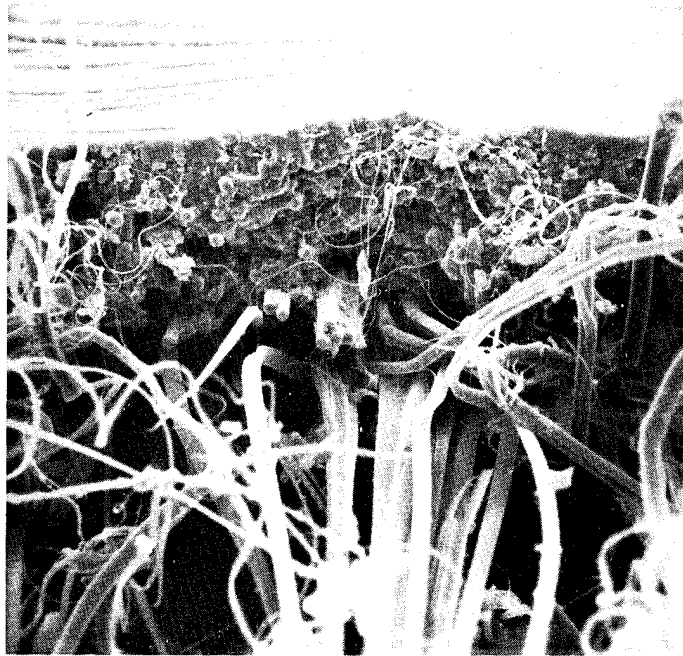
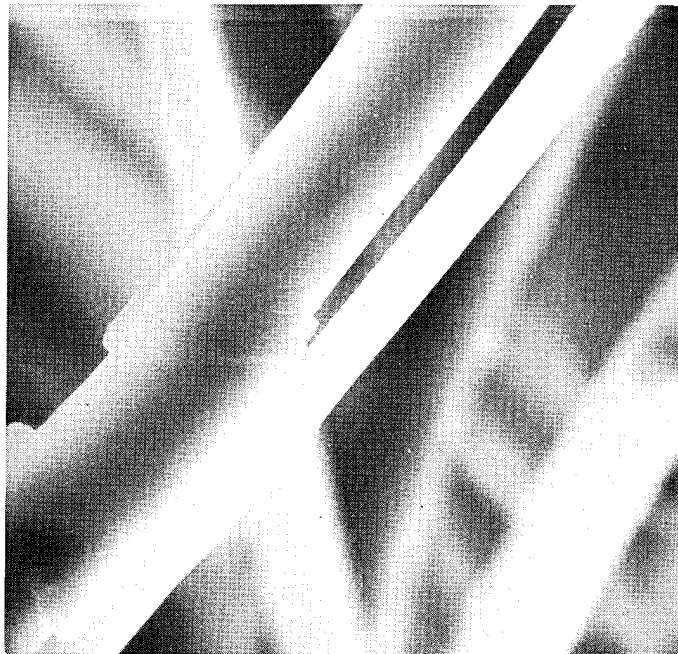
FIGURE 30. 200X SEM - TENSILE SIDE OF IMPACT SURFACE OF PANEL #5,
MODULITE 5206/PRD-49

The fracture surface of a hybrid panel impact specimen fabricated from Modulite 5206 and PRD-49 III is shown in Figures 30 and 31. Figure 30 shows the multimode fracture associated with the hybrid. The graphite ply underwent its characteristic "brittle" failure and the PRD-49 ply underwent its characteristic "ductile" failure. Figure 31 depicts the smooth surface associated with the PRD-49 fiber and the splitting of the fiber due to fracture. Other hybrid panels not shown, fractured in multimode fashion with variations of brittle, cleavage fracture, fiber debonding and pullout, and delamination as shown in Appendix C.

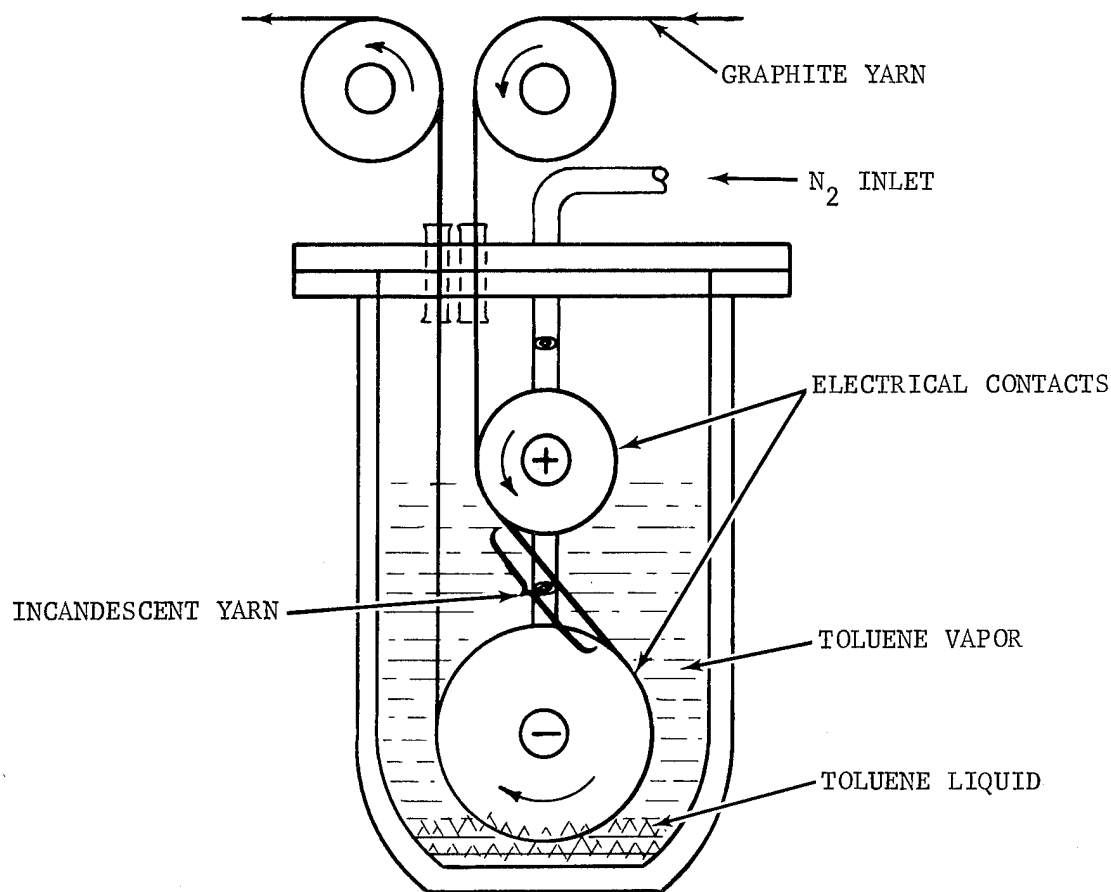
FIGURE 32. EXPERIMENTAL APPARATUS FOR CONTINUOUSLY COATING GRAPHITE YARN WITH CARBON

Yarn was transported through a covered glass jar as shown in Figure 32. An electrical current was caused to flow through a section of yarn suspended above a pool of toluene. The incandescent yarn was quenched in the toluene pool and the liberated heat utilized to form toluene vapor. Above 1000°C, toluene thermally decomposes and forms carbon. Consequently the incandescent yarn was coated with carbon as it passed through the jar. There were some

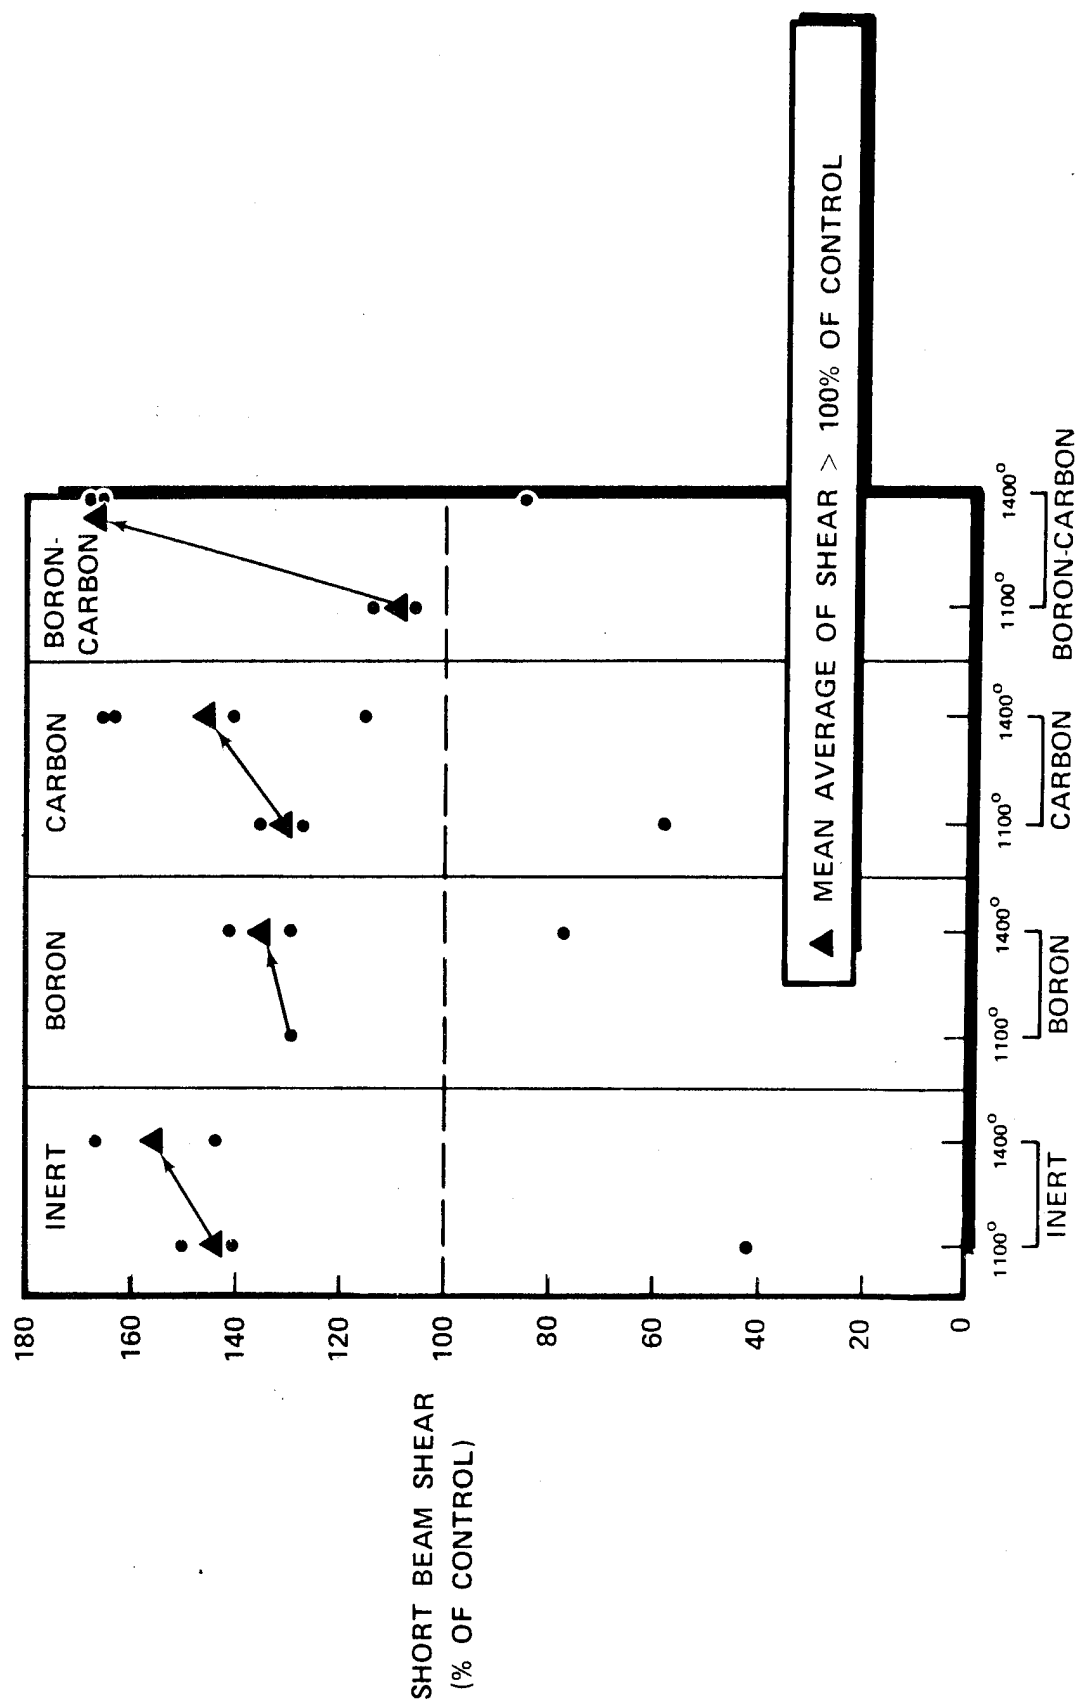
FIGURE 33. VARIATION IN INTERLAMINAR SHEAR STRENGTH RESULTING FROM SURFACE TREATMENT IN FOUR DIFFERENT ENVIRONMENTS

The most conclusive observations were the effect of environment and temperature upon the short beam shear strength of composites fabricated from surface altered fiber. Those results, for treated Thornel 75S yarn, are presented in Figure 33. Note that treatment in an inert environment is akin to heat cleaning as practiced by past investigators.⁽⁹⁾ Consequently, Figure 33 presents the experimental results in such a manner that one can at a glance ascertain the improvement made by the four alternative methods: heat cleaning, boron treatment, carbon treatment and borocarbon treatment.

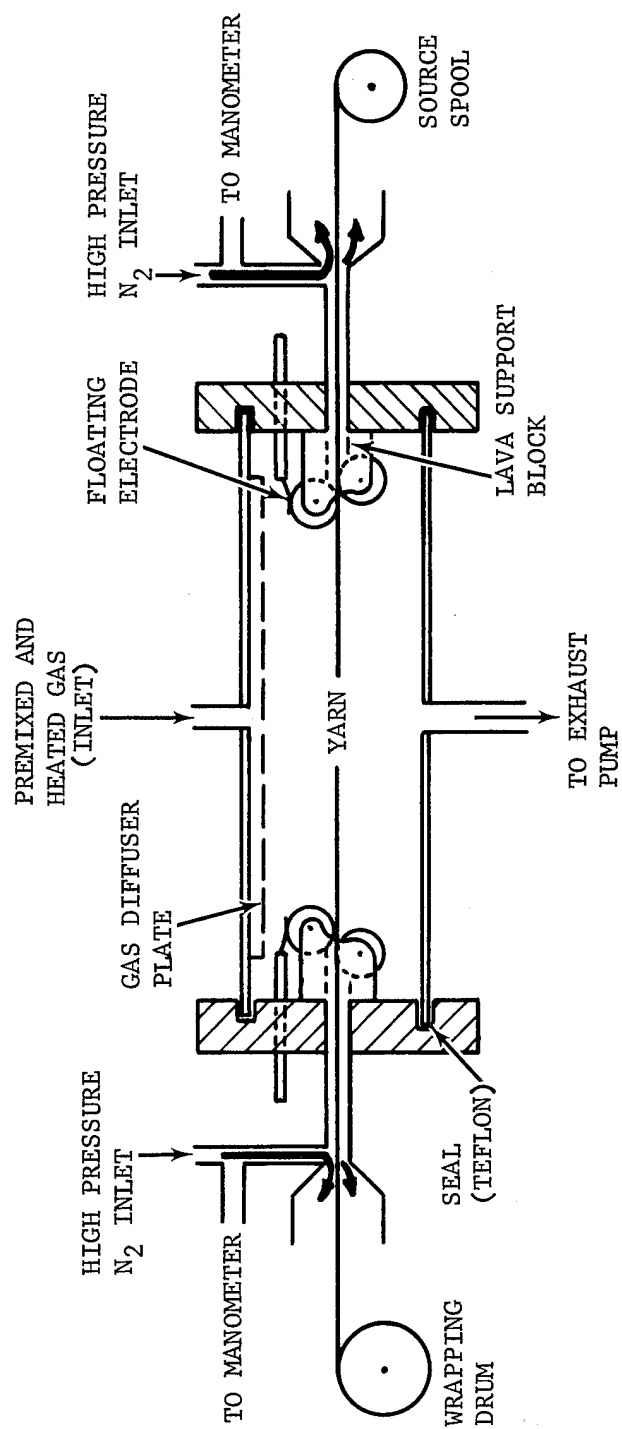
FIGURE 38. HOT FILAMENT SURFACE TREATER

The surface treater is constructed of inconel and monel metals, both of which have relatively high resistance to corrosion by chlorine. The unit consists of essentially three basic parts: a 2.5 inch diameter, 9-inch long cylinder and two end caps onto which electrodes, fiber guide wheels, and gas-sealing curtains are mounted. The end caps which are sealed to the

cylinder by Teflon are removable for cleaning and fiber threading operations. The chamber is equipped with a gas inlet capillary which attaches onto a gas-diffuser plate. The latter is welded to the interior of the chamber at its seams and contains 20 equally spaced small holes. Incoming gas can only enter into the deposition chamber through these small holes. Thus, a fairly uniform mixture of fresh gas and reacted gases is insured throughout the length of the chamber. Although not shown in Figure 38, the exhaust capillary is also covered by a gas-diffuser plate to enhance the uniformity of the gas flow pattern. A pumping station is provided downstream on the exhaust line to permit greater control of gas flow rates of reaction.

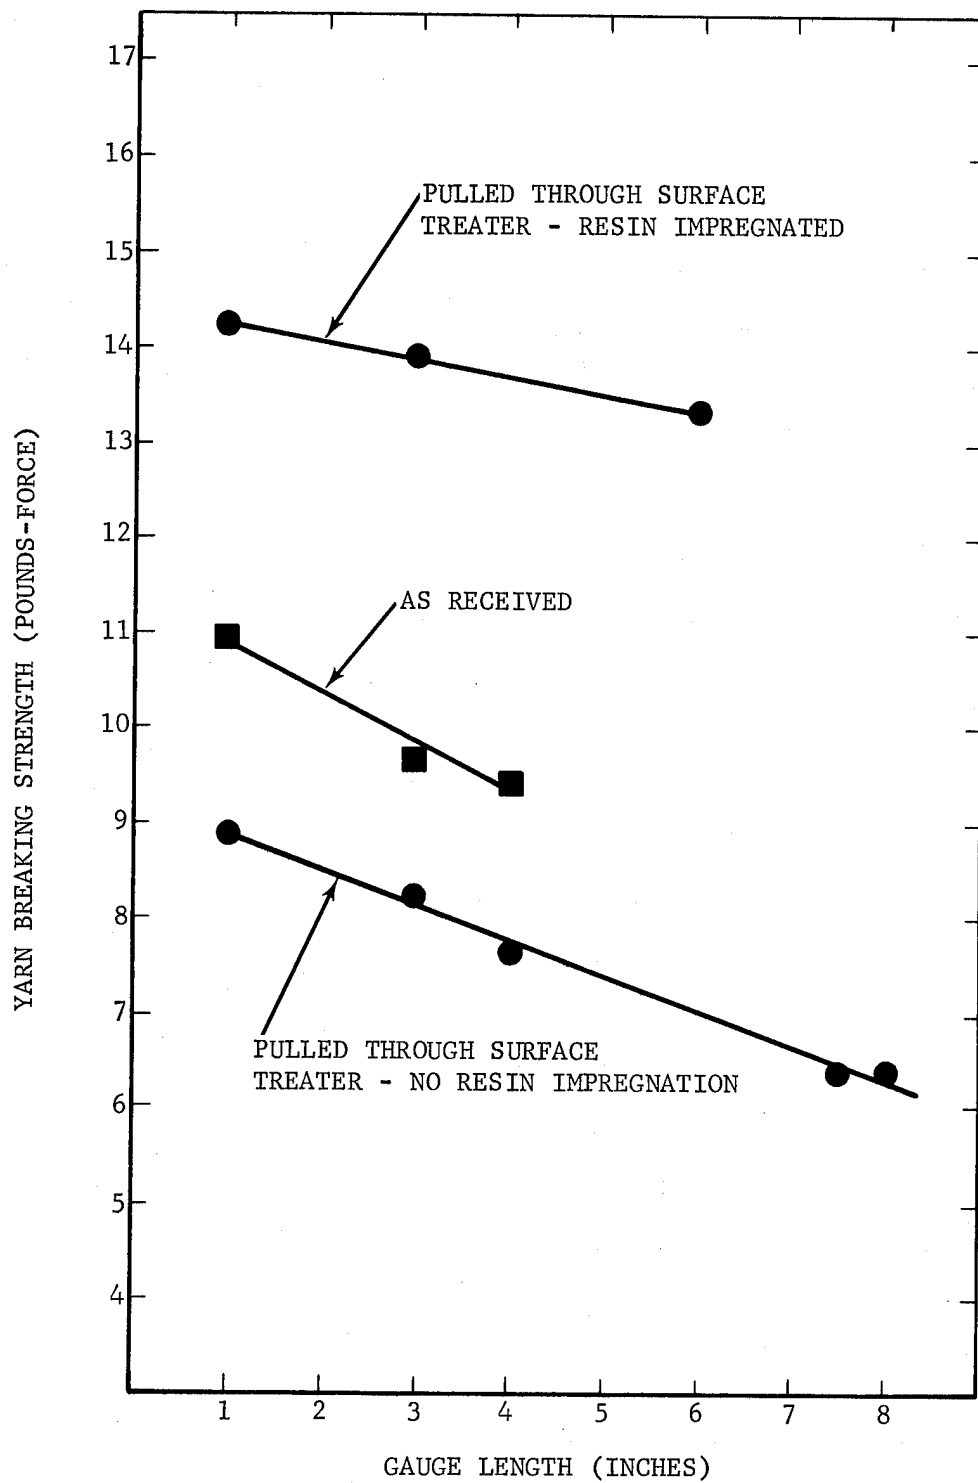
FIGURE 42. VARIATION IN YARN BREAKING STRENGTH OF CONTROL SPECIMENS

Repeated control measurements throughout the experimental period failed to produce higher values.

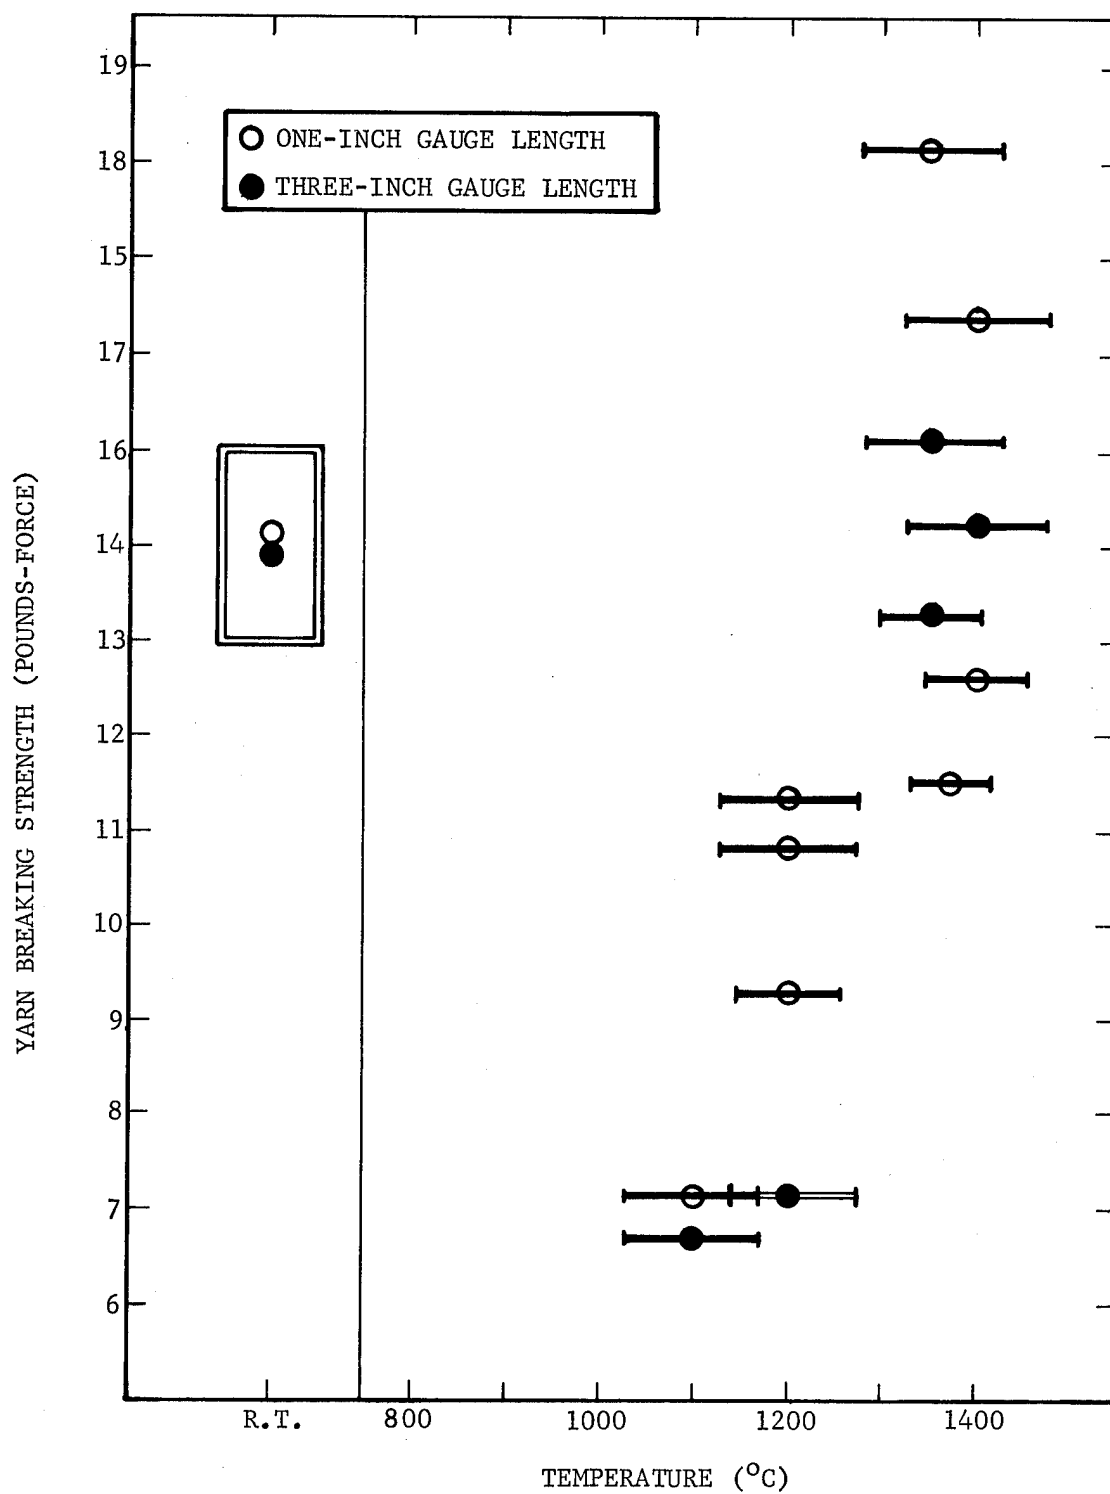
FIGURE 44. EFFECT OF SURFACE DEPOSITED BORON ON YARN BREAKING STRENGTH AS FUNCTION OF DEPOSITION TEMPERATURE

The data in Figure 44 are average values of several measurements from a single processing run. The horizontal lines through the data points represent the variation in, and accuracy of determination, of the incandescent temperature of the yarn during boron deposition. All data are from identical
